## THE PUZZLE OF A CLUSTER OF COLLAPSED EVAPORATOR TUBES

Copyright © 2009 GC Alder

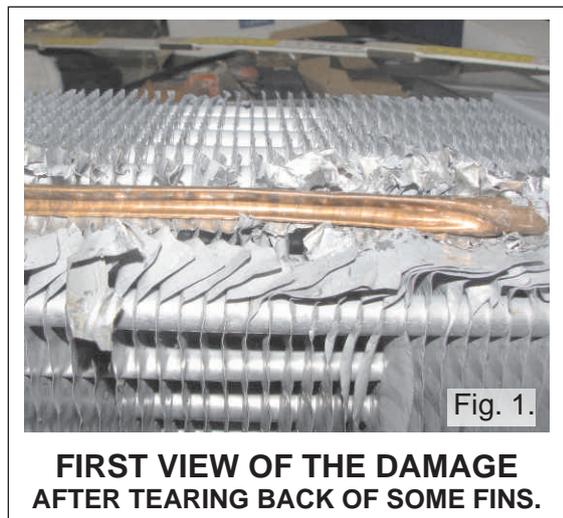
In Fig. 1, parts of some fins have been snipped away to expose the situation. The damage shown here was not isolated. There were multiple repeats of this failure at sites around the bottom of the coil. To get up to speed, we will work through the 'icing' issue. Fig. 2 shows an open-topped container carrying some water at 0°. This water has next been frozen. Alongside, we see the resultant ice. Both are at 0°C. What are the essential differences between the left and right examples?

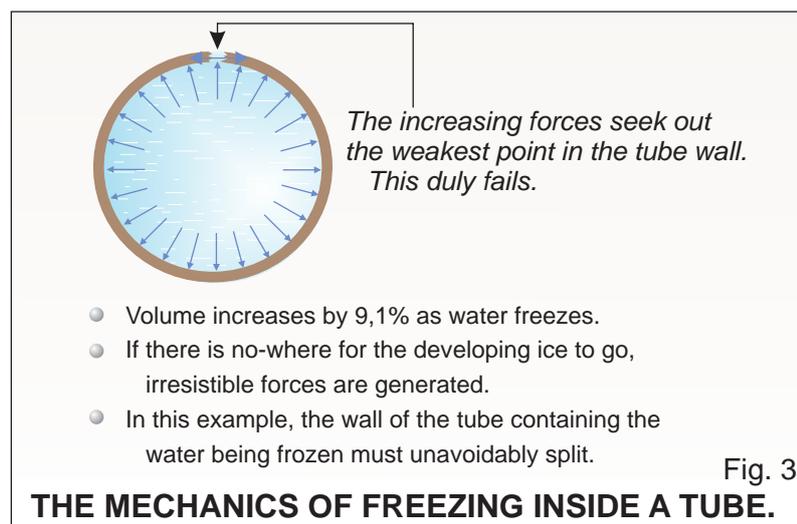
In Fig. 2, there was no top seal present to attempt to restrict the upward expansion of the ice. Indeed, with many types of refrigerator ice tray, you notice a pronounced mound on the top of each ice cube, illustrating this effect. But what happens if there are restrictions which attempt to limit this expansion? The fact is that, for practical consideration, ice is an *incompressible* solid. If it is not permitted to expand freely as it develops, momentous forces are exerted. Something has to give! It is as simple as that. In Fig. 3 a pipe, filled with water, has been exposed to freezing conditions. Maybe there were a couple of colder spots at different points along the way. The water froze solid at these points, 'locking in' the water at our section in Fig. 3. As this now proceeded to freeze, there remained nowhere left for the expanding slurry to go. This caused irresistible forces to be imposed on the pipe. Its wall stretched as far as the metal would allow. The tube then split, as has finally happened in Fig. 3.

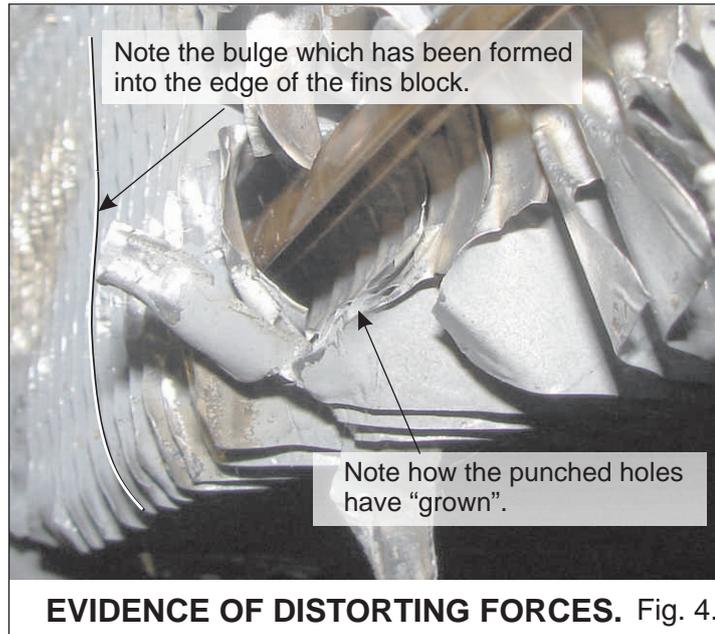
**EVIDENCE OF DISTORTING FORCES.** Fig. 4.

The coil fins naturally would have been square-cut. But take a look at what is visible in Fig. 4. I have inserted a shaped line, to highlight the present bulging shape of what originally was a clutch of straight guillotine cuts. The fins have been markedly stretched outward in manner indicated by this line. Where the tubes penetrate the fins, the punchings originally would have been such as to provide a sliding fit. After assembly of the fins onto the tube bundle, and before the return bends were brazed on, the tubes would have been mechanically expanded so as to be a very tight fit into the fins. This is essential in order to achieve effective heat transfer from the fins and into the walls of the tubes. But just look at the huge clearance which has developed between the fins and the visible tube of Fig. 4!

It is plain that ice has formed to the extent that it thoroughly bridged between the fins, with the ice formation adhering very tightly to the fins. Then further expansion of developing ice has then taken place. Therefore the block of ice has 'grown', due to the enormous amount of force associated with the development of new ice under constrained conditions. As it has 'grown', it has stretched the fins outward as a part of the effort. It is important to note that, once ice has formed at 0°, there follows a slight *contraction* which accompanies any further cooling. Indeed, the ice now follows the 'usual' law of contracting with further temperature reduction. Therefore the problem must be associated with the repeated *development* of ice, as sharply opposed to any effect related to deeper cooling of preexistent ice.

Therefore the expansion of which we see evidence in Fig. 4 can only have been produced by consecutive freezing events taking place in the affected area with each build of new ice being fully encased within preexisting ice. I started out with some puzzlement to attempt explaining the increase in hole size of the fins where the tubes had previously fitted tightly into the punchings, but now am sure this goes some way in that direction.

In working through the evidence, I have come to the conclusion that, across a significant number of defrost cycles, ice had not been completely melted. The evidence of Fig. 4 is that this unmelted ice was hanging up at the bottom of the coil. Can we come up with reasons for this unmelted ice situated near the foot of the coil? Was something limiting or restricting hot gas flow to the lower coil circuit, thereby sabotaging the defrost objective? As an approach, let's look for a reason for oil hang-up affecting that lower circuit.

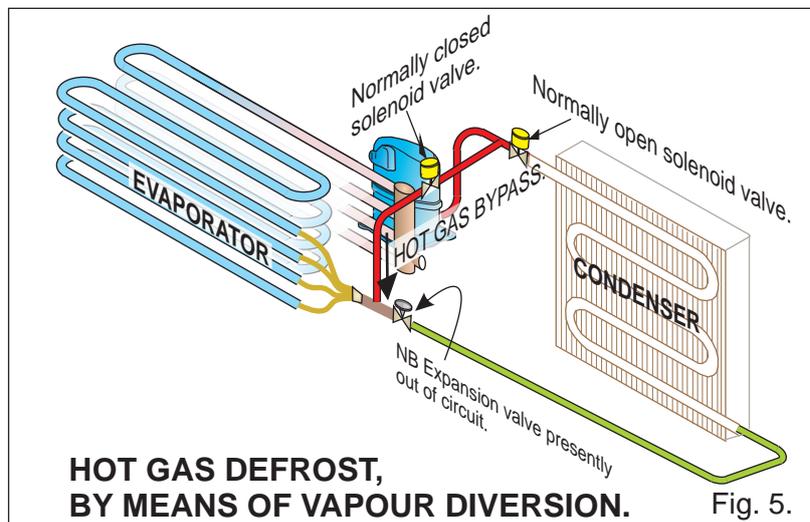
Peter tells me that the hot gas defrost arrangement as installed incorporated two solenoid valves—one to block flow in the hot gas line and a second to admit flow to a bypass loop which injects hot gas into a point between the TX valve and the distributor. Fig. 5 shows how the original installer went about achieving this. Peter says that this is an approach shunned by his company, who do what they feel more comfortable with, which is to apply a 4-way valve hot gas defrosting arrangement. I am sure this must have been highly significant in the sequence of events, and we will work our way through the apparent situation shortly.

This is good and proven technology. What of the 'simple solenoid valve solution' of the coil which failed so dismally? Flip back to Fig. 5. At the start of the defrost cycle, the open hot gas solenoid in the hot gas line will close, and the normally closed solenoid valve, controlling flow in the bypass, will open. Initially there might be traces of liquid to be brought back from the evaporator. This could come back as a spray, not immediately threatening the compressor, but swallowing up such heat as is being produced by operation of the motor. I have actually seen hot gas lines which sweat! Dumb things can and do happen.

Still looking at Fig. 5, you will see that there is a simple run-around taking place. The expansion device has been bypassed. Nothing is present to cause the discharge pressure to be much elevated. The compressor motor will tick away like a sewing machine at quarter throttle. It will add next to nothing in the way of heat. Compare this with the 4-way valve situation of Fig. 7. In that case there was substantial lift, due to the expansion device remaining in circuit. The compressor motor *has* to provide muscle, as it is doing real work, and the heat that comes with that is added to the heat scavenged by way of the outdoor coil.

The 4-way valve solution provides all that is necessary for a workable hot gas defrost arrangement. On the other hand, the solenoid valve alternative delivers just the scrappy amount of heat extracted from an under-worked motor to perform the defrost task, diluted by any splash-over of liquid which might have been present in the coil at the start of the defrost cycle.

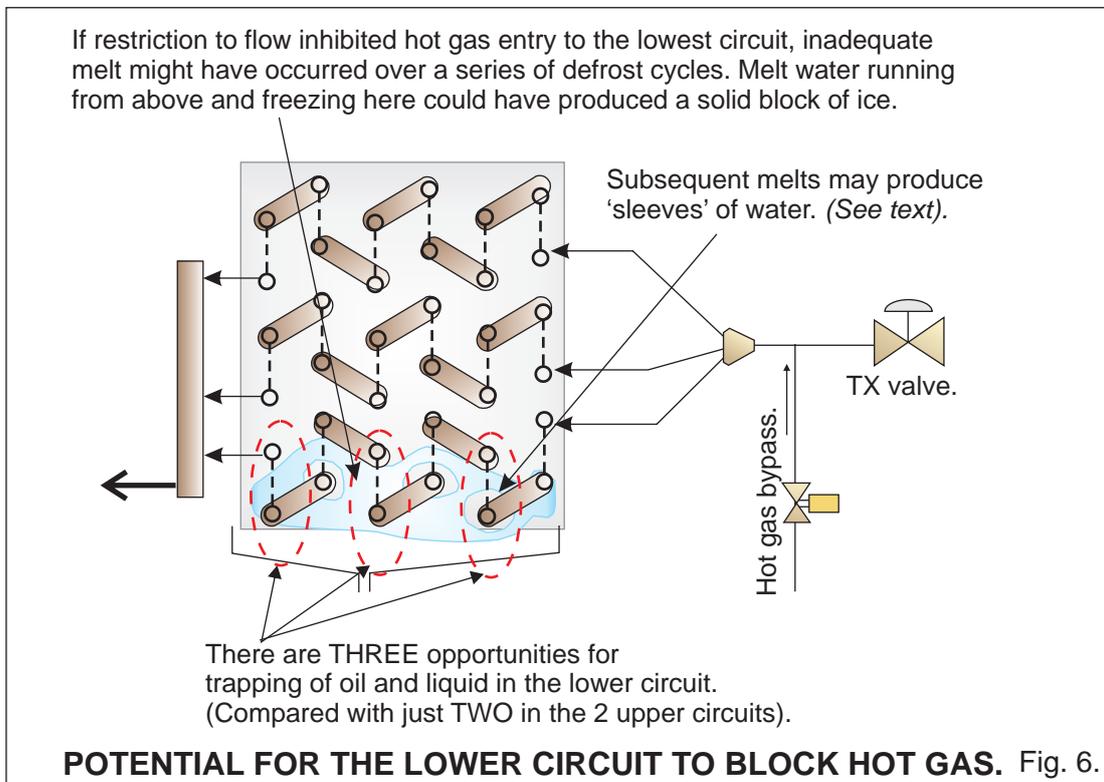
Manometers ('U'-tubes) coupled in series function rather as resistors wired in series, where  $R_1 + R_2 + R_n = R$ . If you look at the coil circuitry as illustrated in Fig. 6 you will note that the two upper circuits each incorporate *two* lifts after refrigerant first enters the coil. If there is oil or liquid refrigerant available to be trapped, it would be trapped by these lifts. But the bottom circuit has been configured so as to result in *three* such lifts. Therefore, if an equal amount of oil has been backed at each such lift, the overall back pressure on the lower circuit will be 3/2 of what it is in each of the upper circuits.

Over and above this, if the bottom circuit has become encased in an unmoving block of ice, it will be denied airflow. That makes it is reasonable to anticipate liquid accumulation here. Therefore, if there is just a limited pressure differential availability of hot gas being blown through the coil the upper circuits, these would blow clear any retained oil and/or liquid *before* the bottom circuit was able to clear itself. This could conceivably have caused reduced melt in the region of that circuit, making possible an undisturbed accumulation of ice in the lower reaches of the evaporator. Thereafter, in subsequent partial defrost cycles, just a 'sleeve' of a few mm of ice surrounding individual tubes of the lowest circuit would melt.

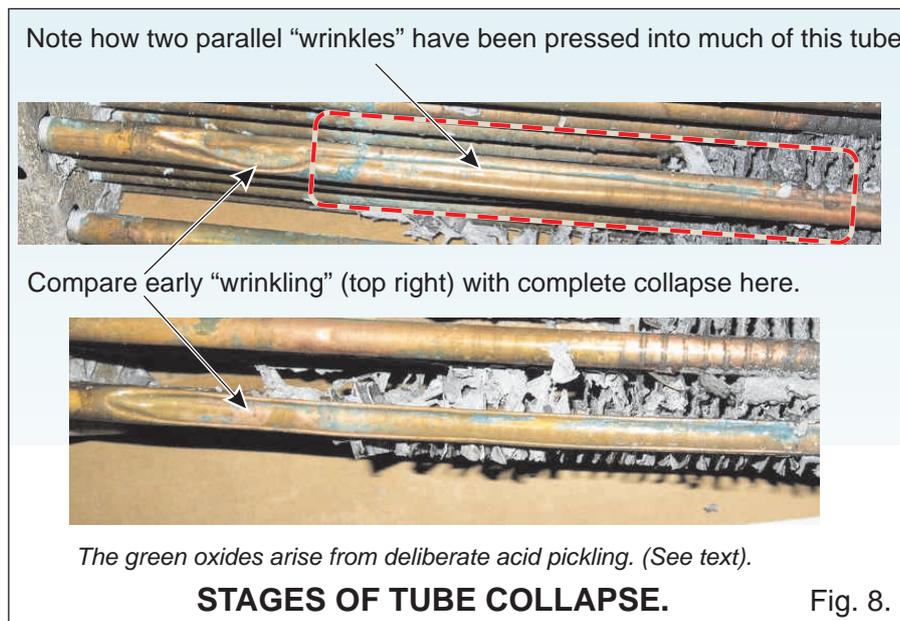
I believe development of this situation could have taken many months, perhaps even longer. After cutting away certain of the fins to allow a peek into a couple of the damage sites, Peter decided to pickle the coil in an acid bath to etch away the aluminium finstock, to enable more detailed examination. I found the photograph utilized in the upper part of

Fig. 8, and taken after this was done, most interesting. You will see two parallel 'wrinkles' which have been formed into the tube wall. Remember, at each refreezing of the melt water, there can be only a finite amount of expansion available to do damage. Some of the expansion, as we have already considered, could well have been directed into producing the warping in the affected fins and bringing about the substantial increase in diameter of the punchings which accommodate the tubes. Of course, immediately the point was reached when the fins no longer tightly 'bit' into the tubes, they would have become ineffectual in conducting heat into the ice accumulations. The affected tubes would effectively become prime surface and the melting effect would be delivered from the tube surfaces alone.

Towards the left of the tube in the upper part of Fig. 8 you will notice a short section where the tube has undergone total collapse, ending up with front pressing against back. Without a doubt, had operation been able to continue for a few additional weeks, this complete collapse would have progressively crept along the entire tube length, taking over the parts already weakened by the 'wrinkling', as has already happened in the lower example of tubing in Fig. 8.
