## THE PUZZLE OF A CLUSTER OF COLLAPSED EVAPORATOR TUBES

Copyright © 2009 GC Alder

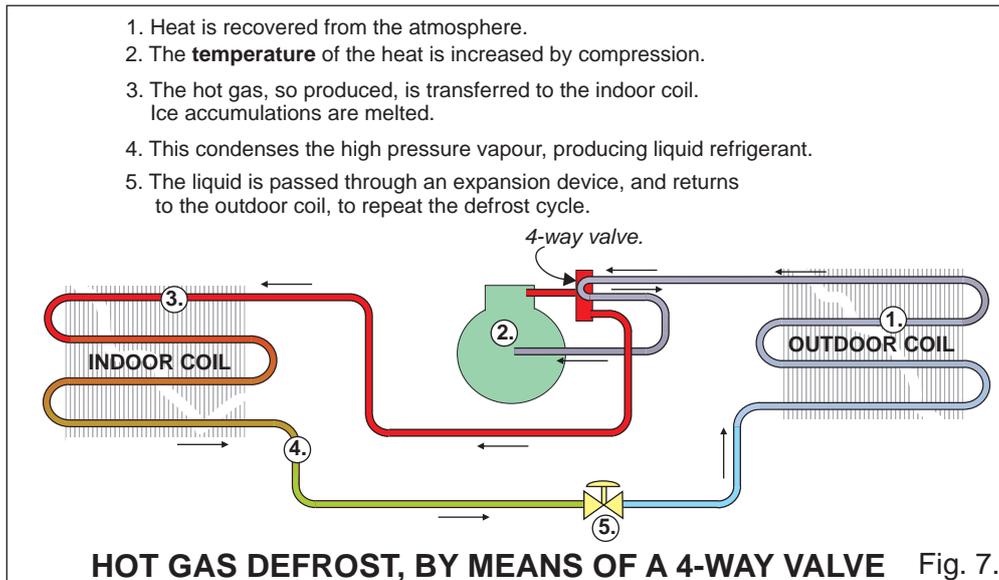
As this melt water would occupy *less* volume than the ice which melted to produce it, (the point which is so easy to overlook) and assuming there is no way in for air, a partial vacuum would result, with the potential to draw in additional melt water in from elsewhere. The available volume of the 'sleeve' left by the small ice melt would now be 100% water-filled. Over the next refrigerated cycle, no blower air would be admitted to the affected areas. The full effect of the  $-40^\circ$  evaporating condition would be imposed on this contained water, rapidly freezing it solid. This event of course would demand 9% more volume. If the block of ice was capable of being stretched, the block itself would be pushed outward. In my mind, Fig. 4 makes it plain that this has happened, at least for some of the time.

If we assume that early in the piece the onset of hot gas injection, with its accompanying tube linear expansion, resulted in some distortion of the copper tubes as it was introduced (bear in mind the fins would have been solidly locked in ice) an initial clearance could have developed between the fin spacing collars at the punchings and the tube wall. Any initial collapse of the tube wall would squash down tube diameter, heightening this circumstance. Now, upon resumption of refrigeration, outward expansion by ice building on the low temperature tube will act from *behind* the collars, stretching the holes. I believe the oversized holes in the fins, so plainly visible in Fig. 4, indicates exactly this as having happened over a number of cycles, further expanding the holes each time.
